V80 CRANK DETAIL - PLAN VIEW

Dwg. No. V10301

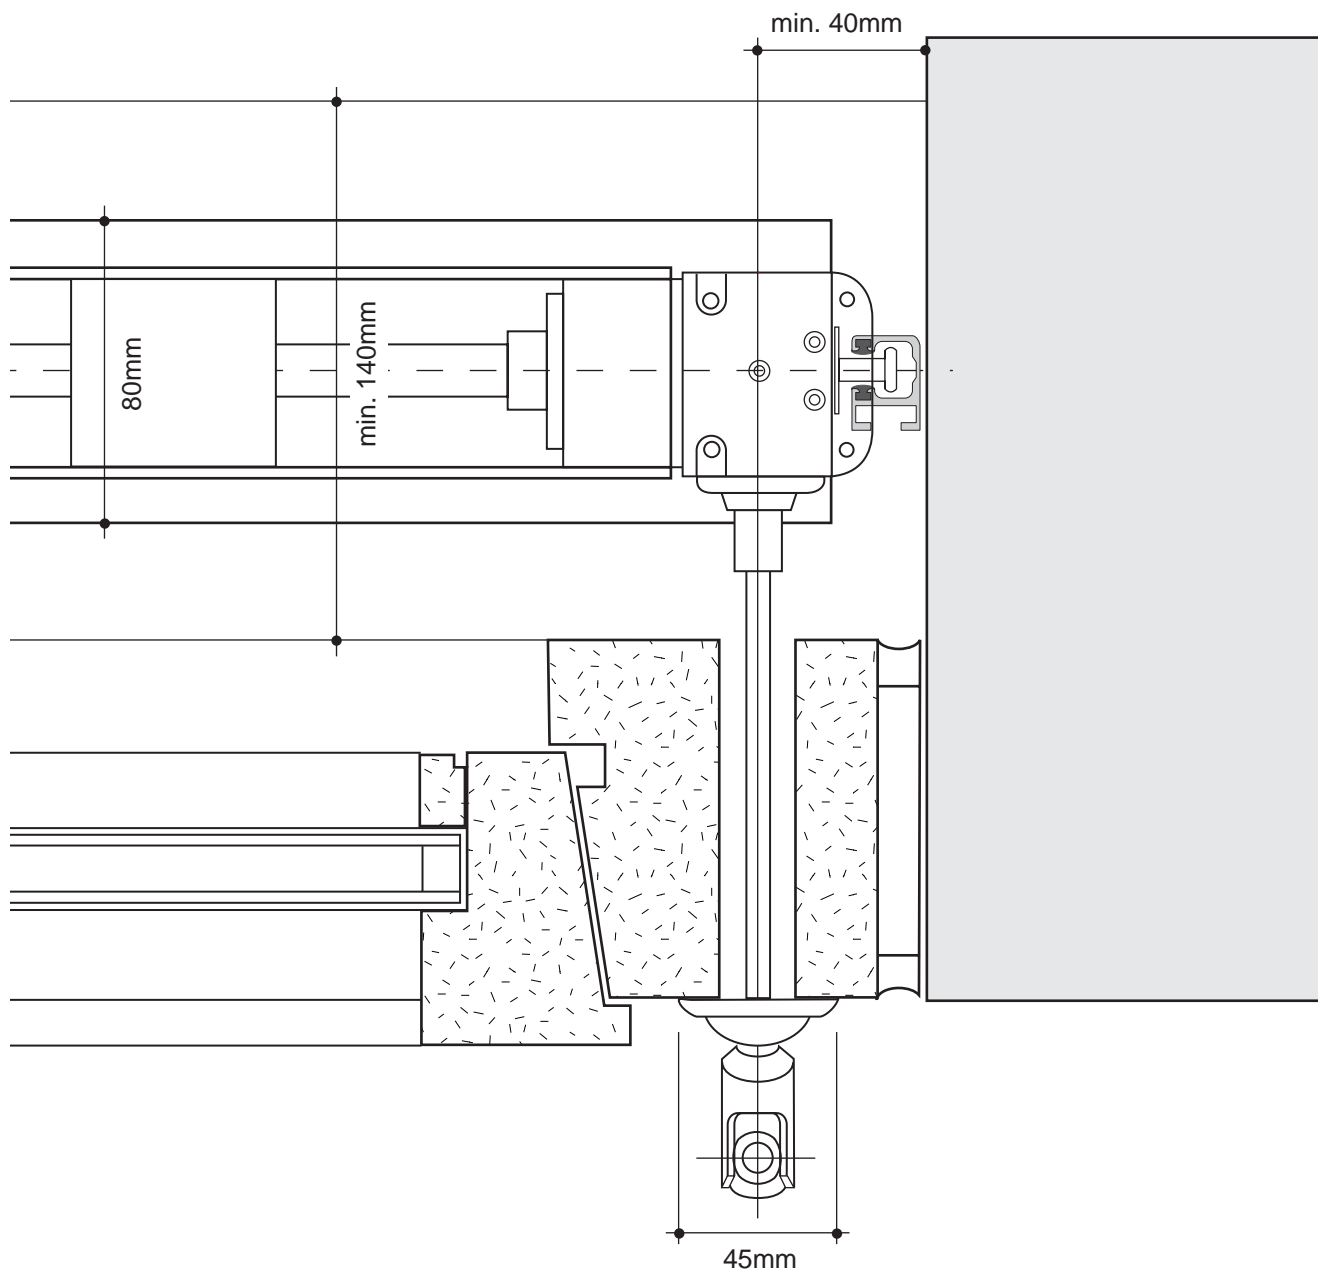
Manually operated blind with end fitted gearbox showing crank penetration in plan view. Manual crank operated blinds require adequate provision to be made for the internal mounting of the crank head as well as a clear path for the crank penetration - unobstructed by structural steel, lintel bars, etc. Gearbox can be positioned at any point within the blind width.
