**V80 HEAD DETAIL - SECTION VIEW**

**Dwg. No. V10101**

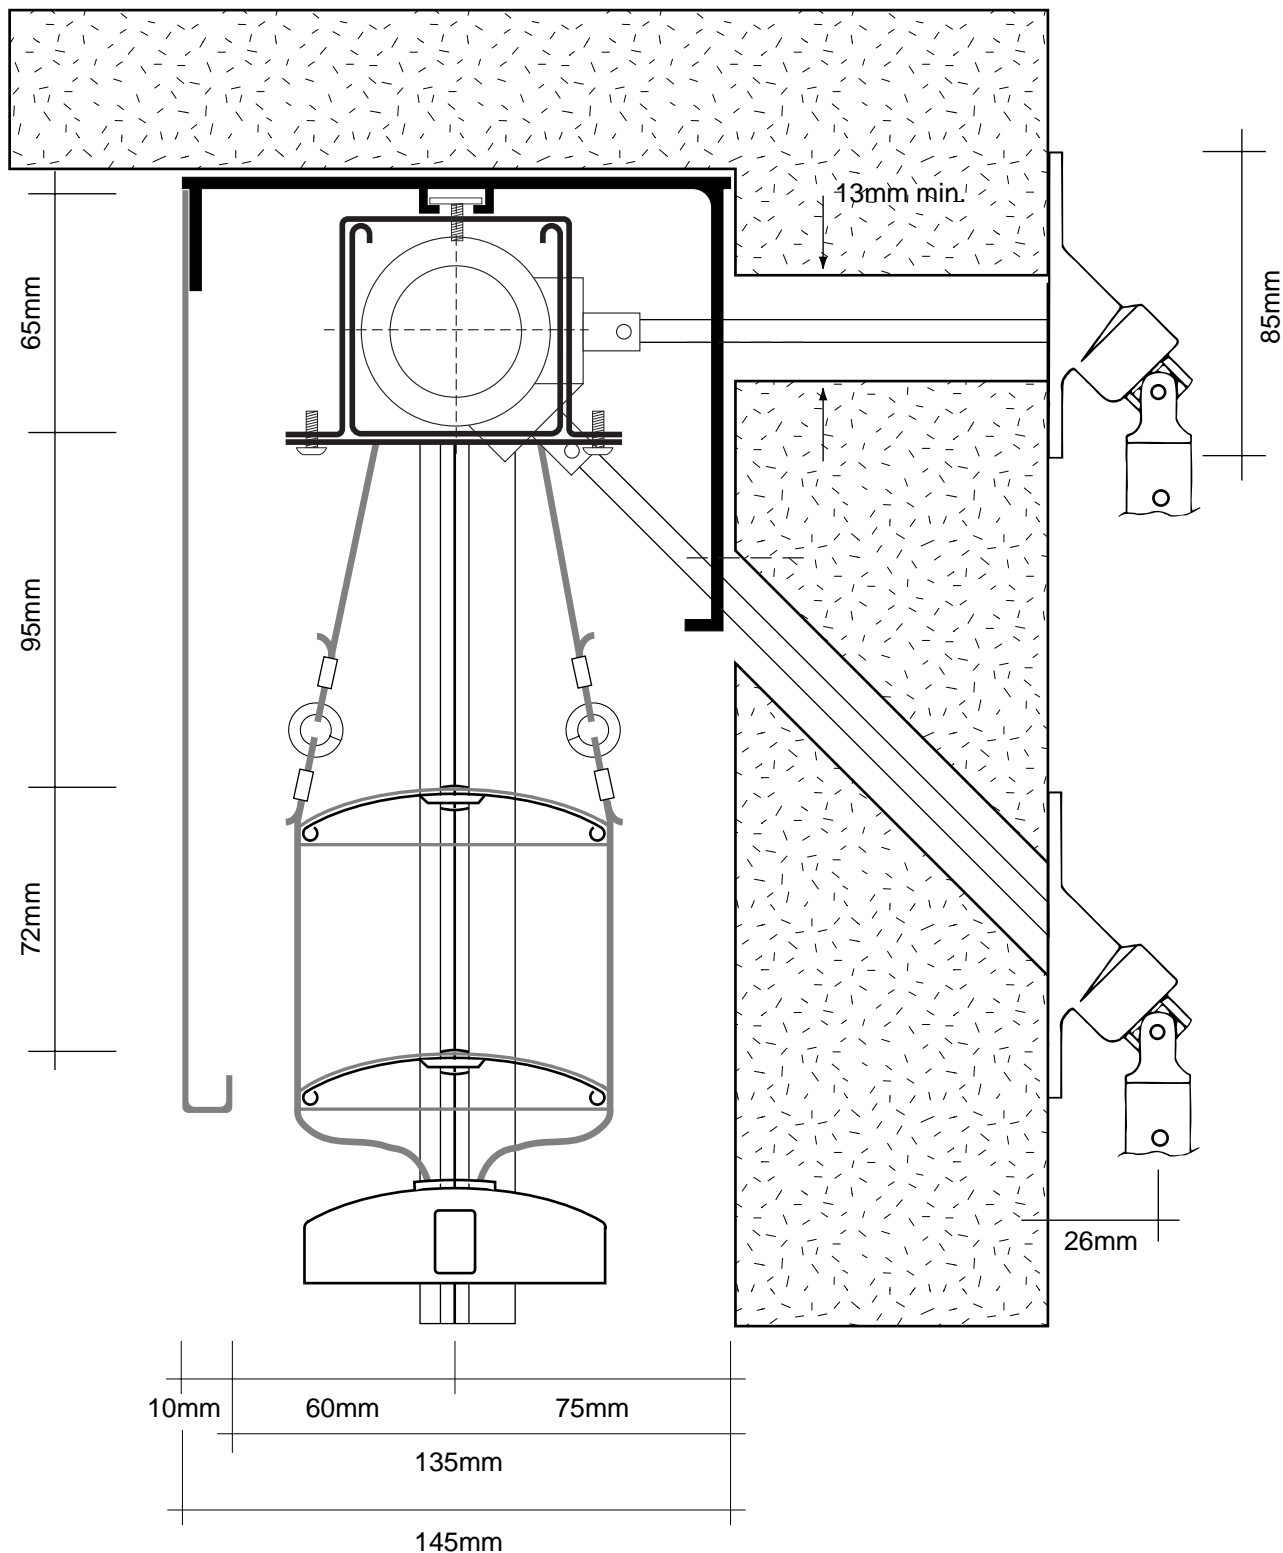
Manually operated blind with gearbox showing 90 & 45 degree crank penetrations in section view. Manual crank operated blinds require adequate provision to be made for the internal mounting of the crank head as well as a clear path for the crank penetration - unobstructed by structural steel, lintel bars, etc. The above example shows a blind fitted with a type 100 cover (refer to dwg. no. V20101).
